Appendix E
Stained Glass Conditions Report

Femenella and Associates, Inc.

FIRST UNITARIAN SOCIETY OF PLAINFIELD PLAINFIELD, NEW JERSEY

STAINED GLASS WINDOW SURVEY

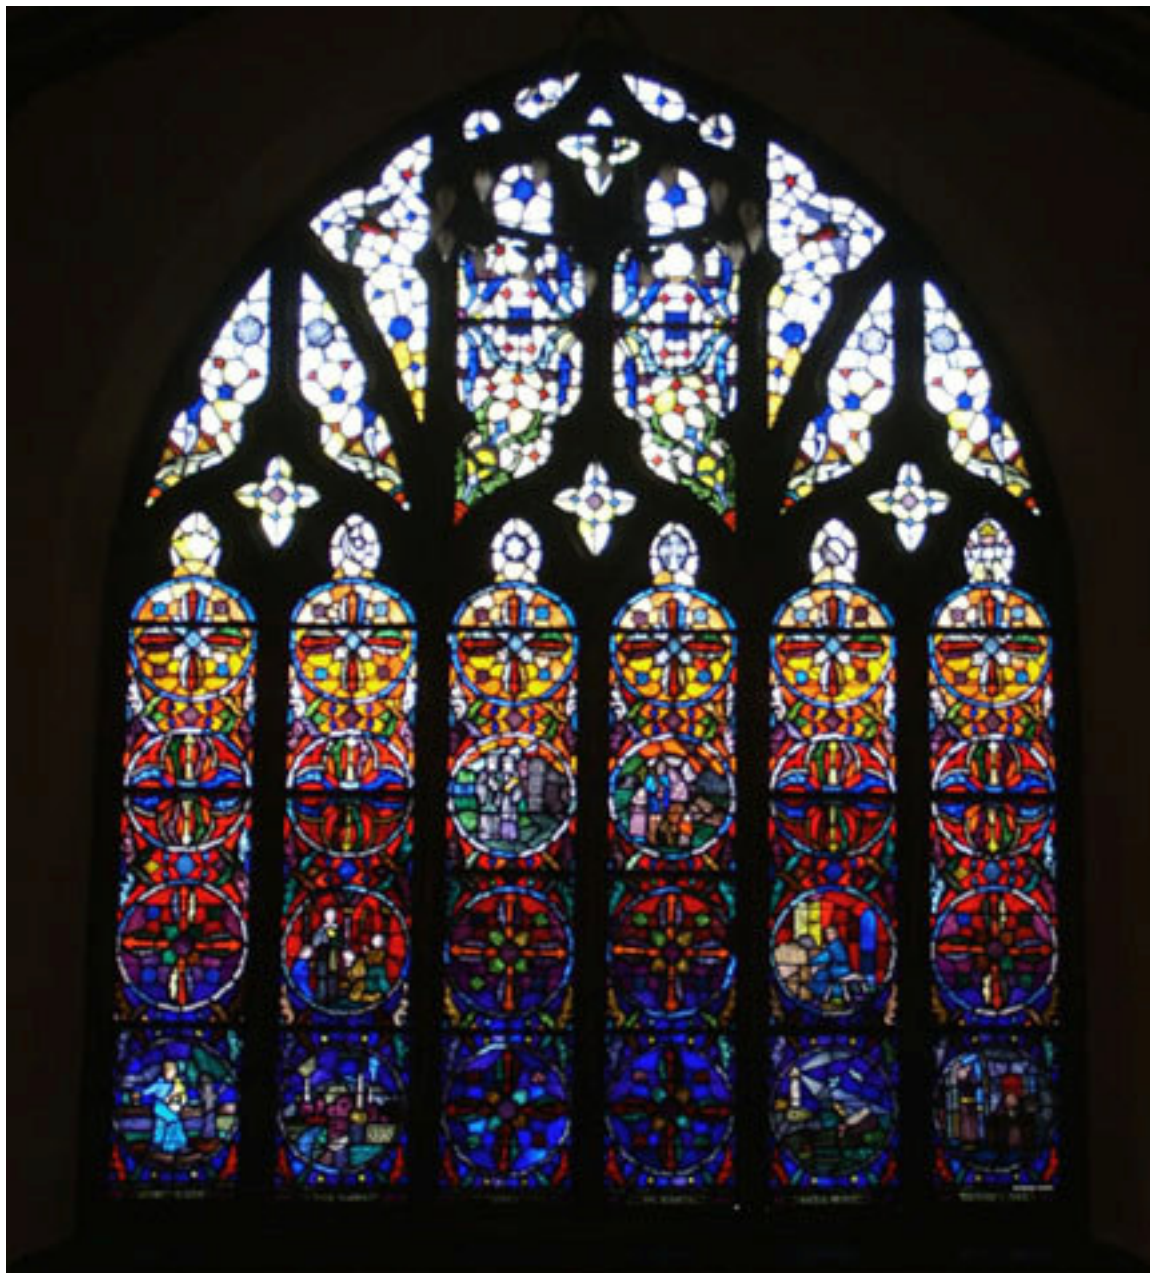
Window 101

Entire window is suffering the effects of water damage. There may be some improperly annealed glass. There is moderate to severe deflection throughout the window. There are many cracks; some have been covered (but not fixed) with “Dutchman repairs.” (However, this may have occurred during the initial installation. If the glass was improperly cooled during its creation, it is subject to unwarranted cracking.) The wooden frame moves with moderate pressure. The wood sill has dropped and is separating from the vertical mullions. There is extensive lead corrosion on both the interior and exterior of the window, which is unusual for a 60-year old window. This is most likely due to the excessive moisture present. There is paint loss on the inscription, again most likely due to excessive moisture in the immediate microenvironment (wall, sill, protective glazing).

Panels(s): All lancet panels show signs of deflection, ranging from moderate to severe. Tracery deflection seems less severe. The support system is comprised of T-bars (primary) and round bars with copper tie wires (secondary). Many of the round bars are too short and do not engage the edges of the frame (See Lancet VI), hence offering no support whatsoever. Lancet IV, Panel B shows excessive deflection. Lancet V, Panel D shows at least seven cracked pieces.

Some repairs have been attempted, including minor releading; replacement of missing glass with clear glass and bad “cold paint” (Lancet V); the aforementioned “Dutchman”; Lancet

III, Panel D has poor repairs and resoldering. Lancet II, Panel D (the bottom panel) and Lancet V, Panel D have poor replacement glass. In addition, the texture of the paint is questionable.

Panel(s): Entire window needs to be removed and releaded. Broken pieces need to be edge-glued, and/or repaired with copper foil. At least three (3) pieces need to be repainted. Possible use of cover plates. Perform annealing test on some of the glass.

P.G.: Existing protective glazing should be removed and discarded. System must be redesigned for proper air exchange or substituted with a protective screen system.

The first priority is to address Window 101. This is the most important window in Sanctuary and it is suffering from severe structural issues. The stained glass must be entirely removed, brought to the studio and fully restored, including complete releading.

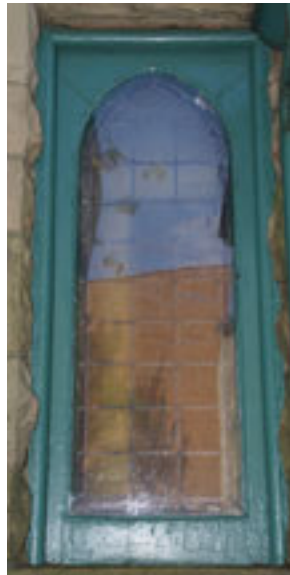
Panel(s): Moderate lead corrosion. Minor metal fatigue. Minor deflection.

Panel(s): **A** **Priority:** Remove protective glazing and discard. Waterproof panel in-situ.

C **Priority:** Remove and relead.

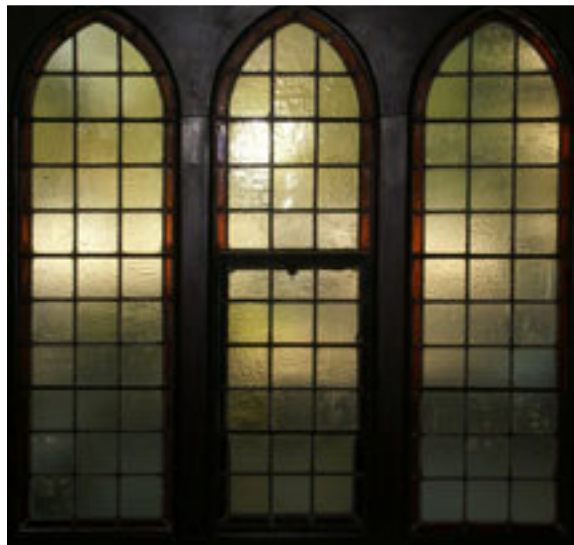
WINDOW 107

Panel(s): Moderate lead corrosion. Minor metal fatigue. Minor deflection.

Ventilator(s): Moderate to severe lead corrosion. Moderate to severe metal fatigue. Minor deflection.

C Priority: Remove balance of center lancet and both side lancets; relead.

Ventilator(s): **A Priority:** Remove ventilator sash and frame. Relead ventilator panel. Sandblast and powder coat ventilator. Make operable.

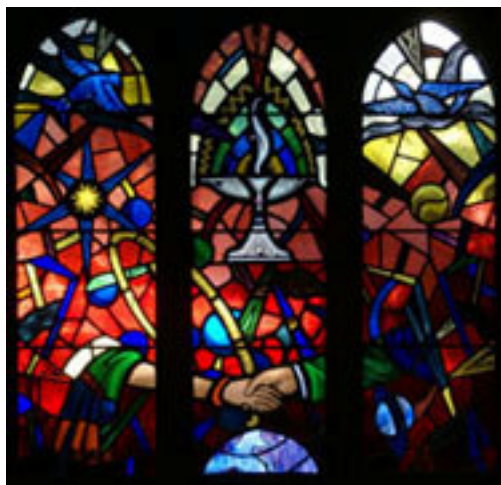
WINDOW 108

There is moderate to severe deflection throughout the window. There are five pieces of broken glass. There is extensive lead corrosion on both the interior and exterior of the window, which is unusual for a window of this age. This is most likely due to the excessive moisture present. The paint appears to be stable.

Work Plan: **B Priority:** Remove and reread. Remove and discard protective glazing. Consider using protective screens if the Society wants to continue to protect this window.

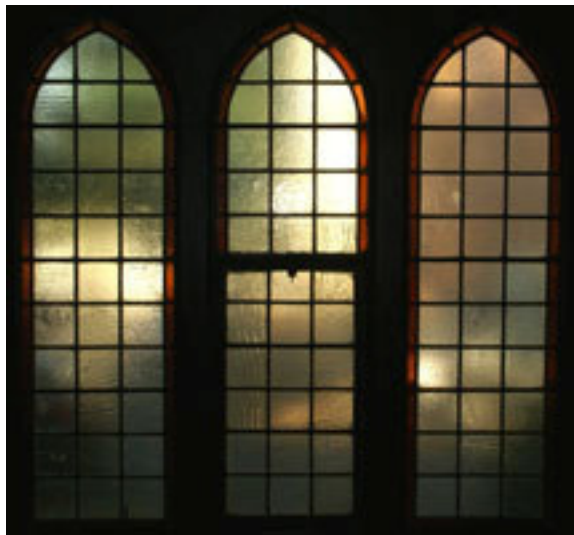
WINDOW 109

Panel(s): Some broken glass. Moderate lead corrosion. Minor metal fatigue. Minor deflection.

Ventilator(s): Moderate to severe lead corrosion and metal fatigue. Minor deflection. Piggyback protective glazing. One good replacement on Lancet II.

C Priority: Remove balance of center lancet and both side lancets; relead.

Ventilator(s): **A Priority:** Remove ventilator sash and frame. Relead ventilator panel. Sandblast and powder coat ventilator. Make operable.

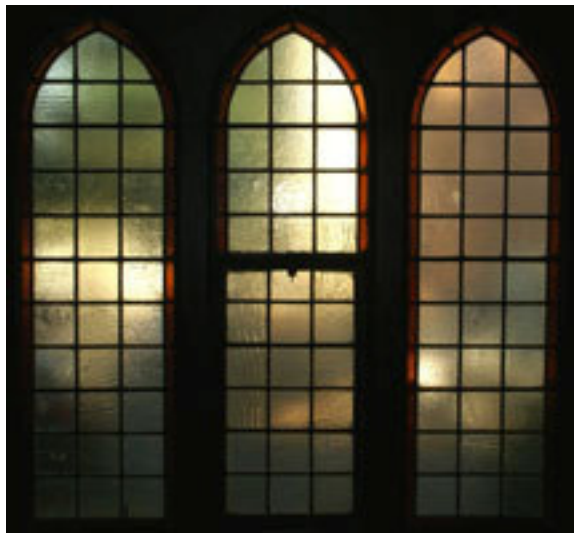
WINDOW 151

Panel(s): Moderate to severe lead corrosion. Minor metal fatigue. Minor deflection.

Ventilator(s): Moderate to severe lead corrosion. Moderate to severe metal fatigue. Minor deflection. Does not operate.

Panel(s): **A** **Priority:** Remove protective glazing and discard. Remove balance of center lancet and both side lancets; relead

Ventilator(s): **A** **Priority:** Remove ventilator sash and frame. Relead ventilator panel. Sandblast and powder coat ventilator. Make operable.

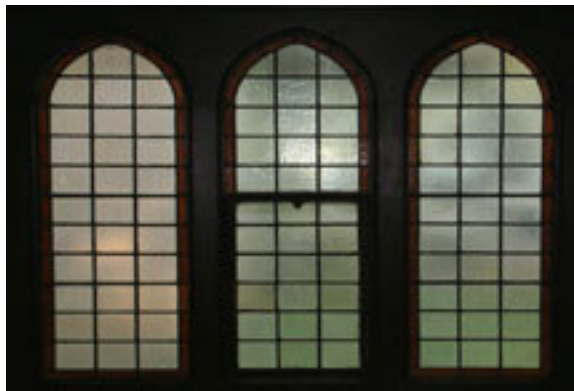
WINDOW 152

Panel(s): Moderate to severe lead corrosion. Minor metal fatigue. Minor deflection.

Ventilator(s): Moderate to severe lead corrosion. Moderate to severe metal fatigue. Minor deflection. Does not operate.

Panel(s): **A** **Priority:** Remove protective glazing and discard. Remove balance of center lancet and both side lancets; relead

Ventilator(s): **A** **Priority:** Remove ventilator sash and frame. Relead ventilator panel. Sandblast and powder coat ventilator. Make operable.

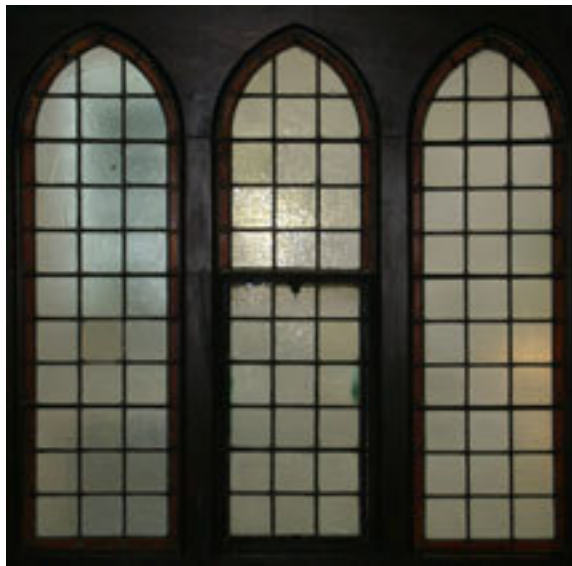
WINDOW 153

Panel(s): Moderate to severe lead corrosion. Minor metal fatigue. Minor deflection.

Ventilator(s): Moderate to severe lead corrosion. Moderate to severe metal fatigue. Minor deflection. Does not operate.

Panel(s): **A Priority:** Remove protective glazing and discard. Remove balance of center lancet and both side lancets; relead.

Ventilator(s): **A Priority:** Remove ventilator sash and frame. Relead ventilator panel. Sandblast and powder coat ventilator. Make operable.

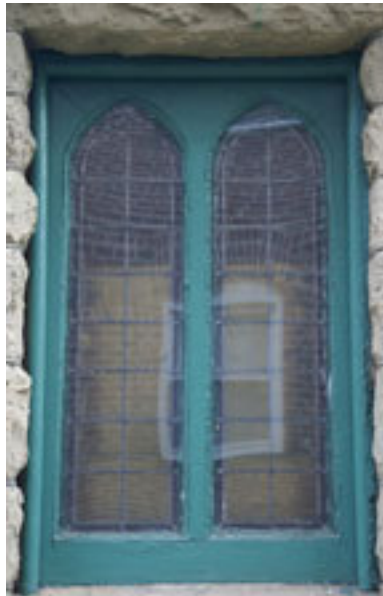
WINDOW 154

Panel(s): Six broken pieces. Moderate to severe lead corrosion. Minor metal fatigue. Minor deflection.

Panel(s): **A Priority:** Remove protective glazing and discard. Remove lancets; relead.

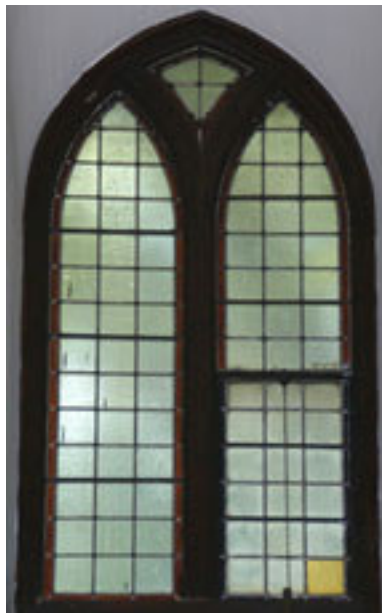
WINDOW 201

Panel(s): No broken glass. Minor lead corrosion. Minor metal fatigue. Minor deflection.

Ventilator(s): One bad replacement piece. Moderate to severe lead corrosion. Moderate to severe metal fatigue. Minor deflection.

C Priority: Remove both lancets; relead.

Ventilator(s): **A Priority:** Remove ventilator sash and frame. Relead ventilator panel. Sandblast and powder coat ventilator. Make operable.

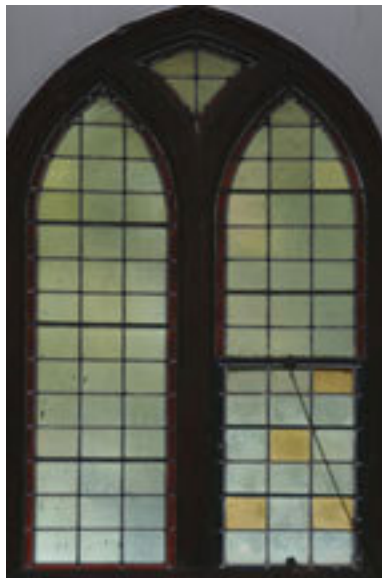
WINDOW 202

Panel(s): No broken glass. Minor lead corrosion. Minor metal fatigue. Minor deflection.

Ventilator(s): Four (4) bad replacements in ventilator. Moderate to severe lead corrosion. Moderate to severe metal fatigue. Minor deflection.

C Priority: Remove lancets; relead.

Ventilator(s): **A Priority:** Remove ventilator sash and frame. Relead ventilator panel. Sandblast and powder coat ventilator. Make operable.

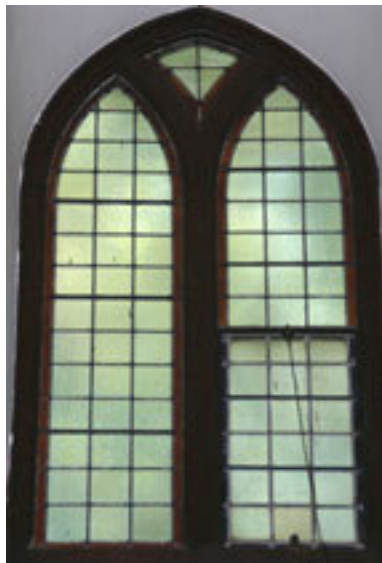
WINDOW 203

Panel(s): No broken glass. Minor lead corrosion. Minor metal fatigue. Minor deflection.

Ventilator(s): No poor replacements. Moderate to severe lead corrosion. Moderate to severe metal fatigue. Minor deflection.

C Priority: Remove lancets; relead.

Ventilator(s): **A Priority:** Remove ventilator sash and frame. Relead ventilator panel. Sandblast and powder coat ventilator. Make operable.

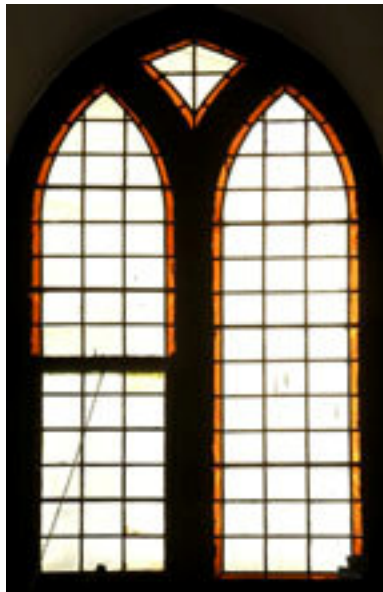
WINDOW 211

Panel(s): Three (3) bad breaks in the tracery, two (2) bad breaks in the lower right corner of the right lancet. One (1) bad replacement in the right lancet. Minor lead corrosion. Minor metal fatigue. Minor deflection.

Ventilator(s): One bad replacement piece. Moderate to severe lead corrosion. Moderate to severe metal fatigue. Minor deflection.

Panel(s): **A Priority:** Repair broken glass in lower right corner. Remove lancet and relead. Remove protective glazing and discard. In-situ waterproof upper panel above ventilator and complete other lancet.

C Priority: lancets; relead.

Ventilator(s): **A Priority:** Remove ventilator sash and frame. Relead ventilator panel. Sandblast and powder coat ventilator. Make operable.

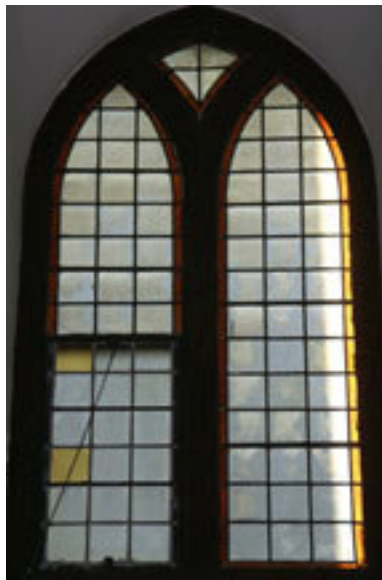
WINDOW 212

Panel(s): No broken glass. Minor lead corrosion. Minor metal fatigue. Minor deflection.

Ventilator(s): Two (2) bad replacements in ventilator. Moderate to severe lead corrosion. Moderate to severe metal fatigue. Minor deflection.

C Priority: Remove lancets; relead.

Ventilator(s): **A Priority:** Remove ventilator sash and frame. Relead ventilator panel. Sandblast and powder coat ventilator. Make operable.

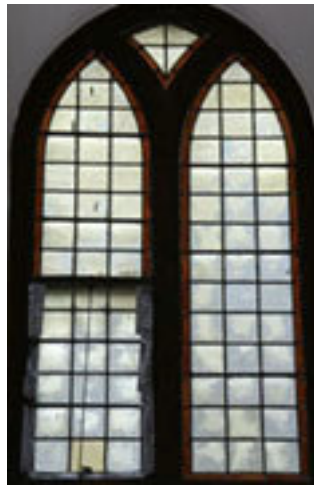
WINDOW 213

Panel(s): No broken glass. Minor lead corrosion. Minor metal fatigue. Minor deflection.

Ventilator(s): One bad replacement piece. Duct tape on perimeter of ventilator panel. Moderate to severe lead corrosion. Moderate to severe metal fatigue. Minor deflection.

C Priority: Remove balance of center lancet and both side lancets; relead.

Ventilator(s): **A Priority:** Remove ventilator sash and frame. Relead ventilator panel. Sandblast and powder coat ventilator. Make operable.

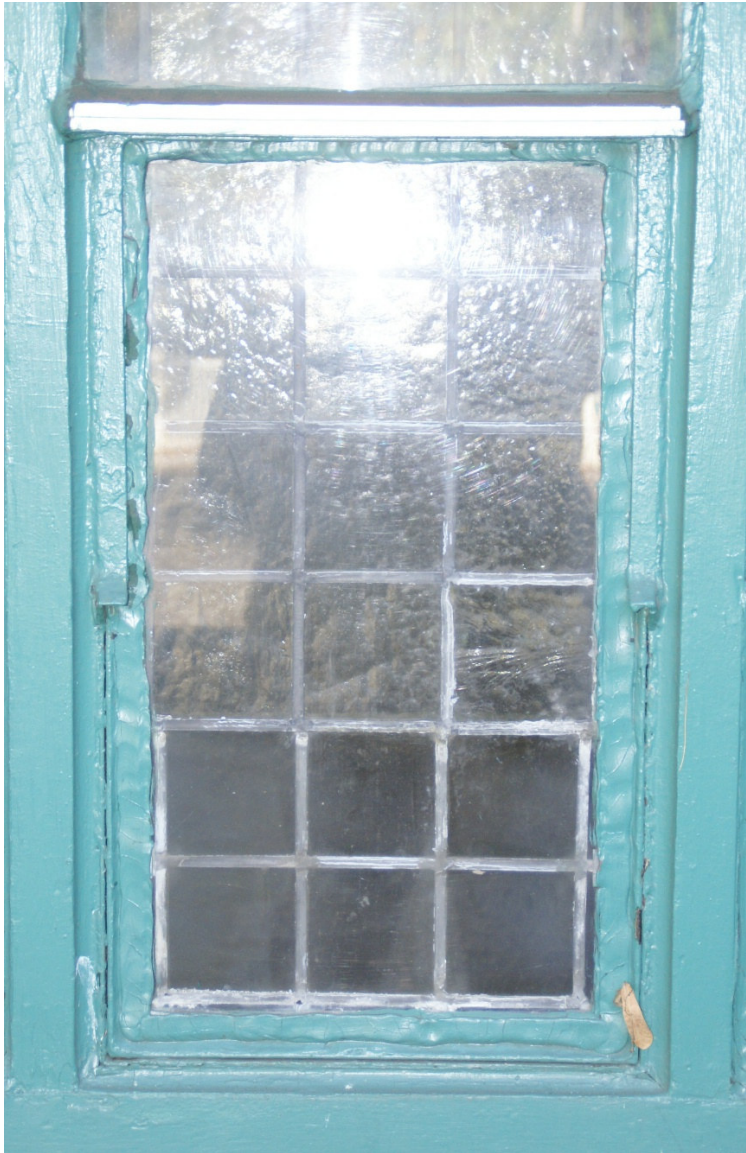
Photo 3 – Ventilator

The windows are set in one of two ways. Most of the panels are set directly into a rebate in the wood frame or sash. The panels are set from the exterior and they are retained with nails and hard setting putty. A number of these windows have operating ventilator sections. The ventilator stained glass is set into a steel operating sash that sits within the steel ventilator frame (See Photo 3 – Part IV).

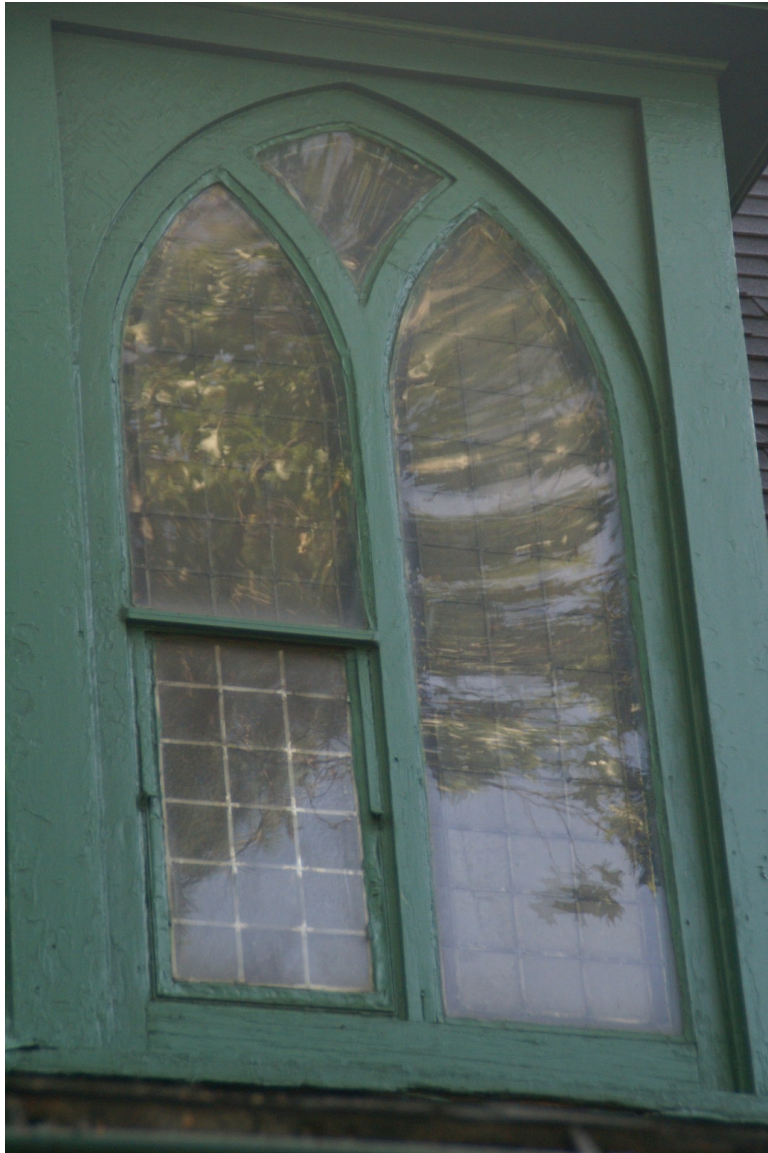
Photo 4 – PG

All of the windows have protective glazing (PG) applied to the exterior. The glazing is primarily plastic. Some of the plastic appears to be acrylic and the balance is polycarbonate (See Photo 4 - Part IV). The PG is applied in two ways. Most of it is installed into the profile of the wood frame. It is secured with screws and caulk. The ventilator sections are single glazed. Where the ventilators have been left operable, the PG has been applied directly to the stained glass and secured with caulk. This method is often referred to as *piggybacked* (See Photo 3 – Part IV). None of the PG is properly vented during its original installation. However, due to deterioration of the sealant materials, some of the PG is now self-venting.

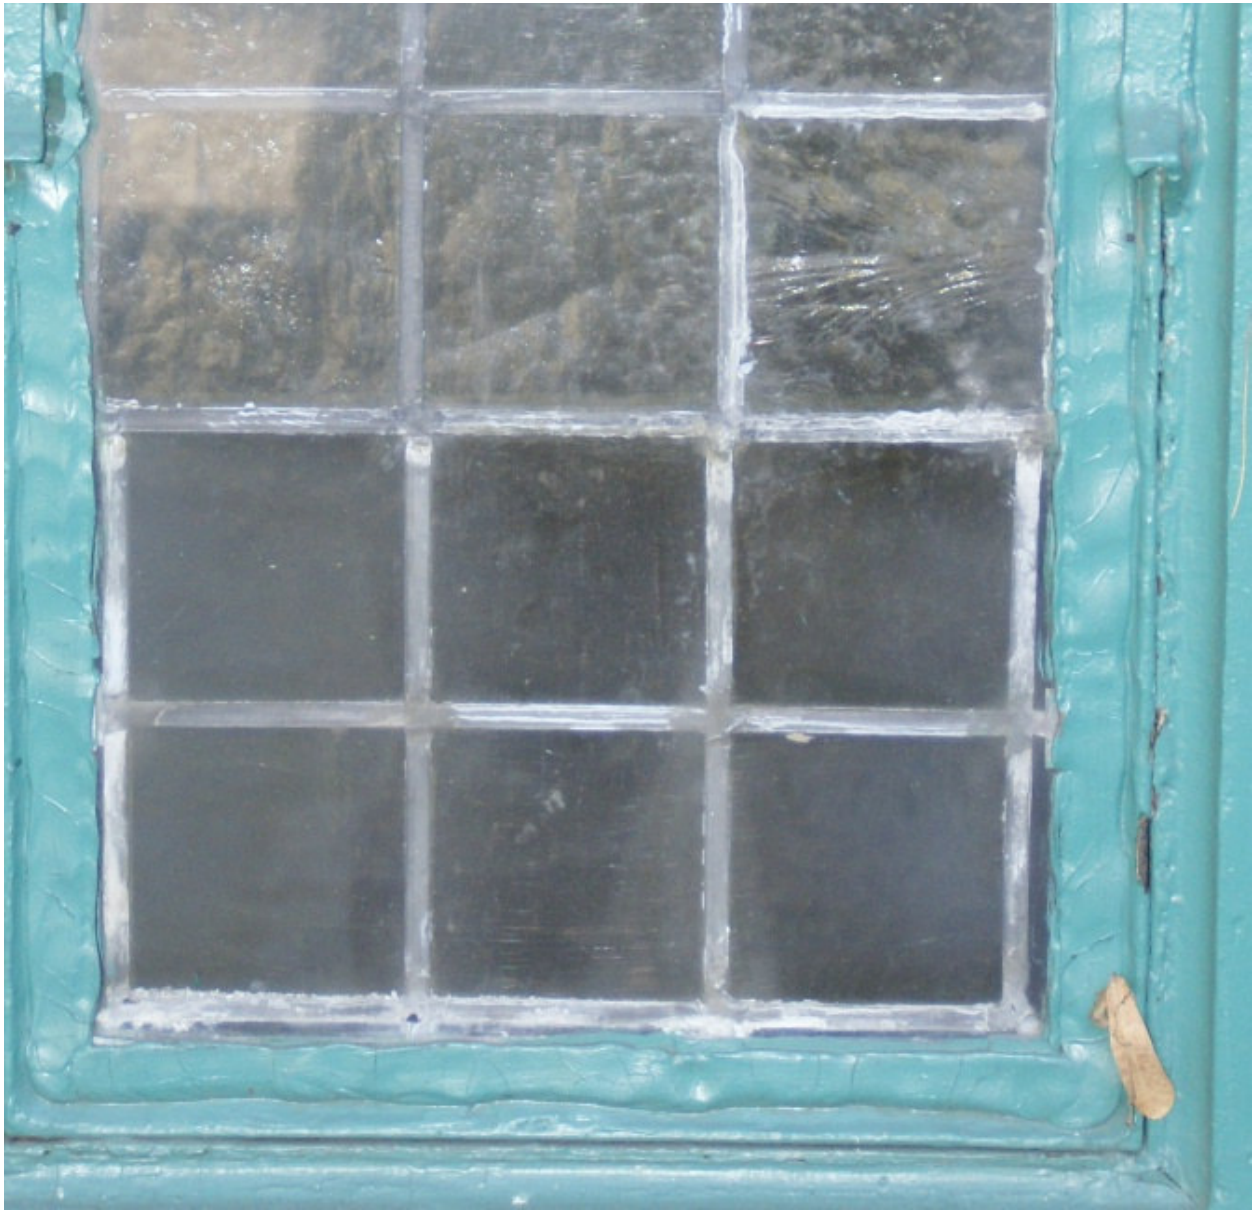
Lead corrodes when exposed to various chemicals in the environment. The typical type of corrosion is from inorganic acids in the air. This causes a dark patina to form on the surface of the lead and is self-sealing, preventing corrosion of the metal below the surface. A second and more damaging type of corrosion is caused by attack by organic acids. This results in a white powder (lead carbonate) forming on the surface of the lead comes. This type of corrosion is not self-sealing. It is difficult to gauge the actual levels of corrosion on many of the windows of the Society due to the obscuring plastic PG. However, wherever the underlying lead comes can be seen, extensive lead carbonate corrosion is present (See Photo 5 - Part IV).

Photo 5 – Lead Corrosion
